GENERAL INSPECTION REPORT (Non-NPDES)

Type of Inspection Pollution Incident	WQM Permit Number PA0006254	County Beaver	Municipality Potter Township
Name and Location of Facility or Pollution Incident Styropek Beaver Valley Site			Entry Time/Date ~0900/21DEC2022
400 Frankfort Road, Monaca, PA 15061			Exit Time/Date ~1130/21DEC2022
Name, Address of Responsible Party Todd Link		Title Environmental Engineer	
400 Frankfort Road			
Monaca, PA 15061		Telephone (724)770-4380	Contacted Yes <input checked="" type="checkbox"/> No <input type="checkbox"/>
SUMMARY OF VIOLATIONS/RECOMMENDATION/COMMENTS:			
<p>The purpose of this visit was a result of a call received by Styropek on DEC 20, 2022 requesting permission to bring a temporary clarifier on line due to a malfunction during routine maintenance. During the visit, I was accompanied by Todd Link. Prior to conducting the visit, we discussed the issue of the sludge falling off the sides of the clarifier and clogging the outlet. In addition to notifying the Department, the facility took actions to reduce production and divert flow through the emergency overflow north settling basin. We also discussed the previous visit conducted October 26, 202

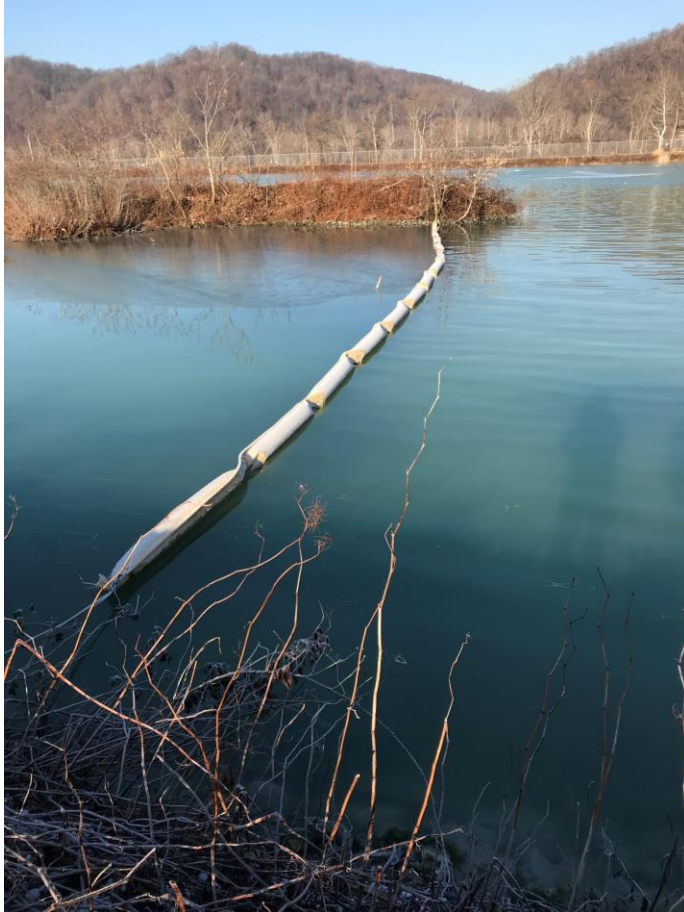
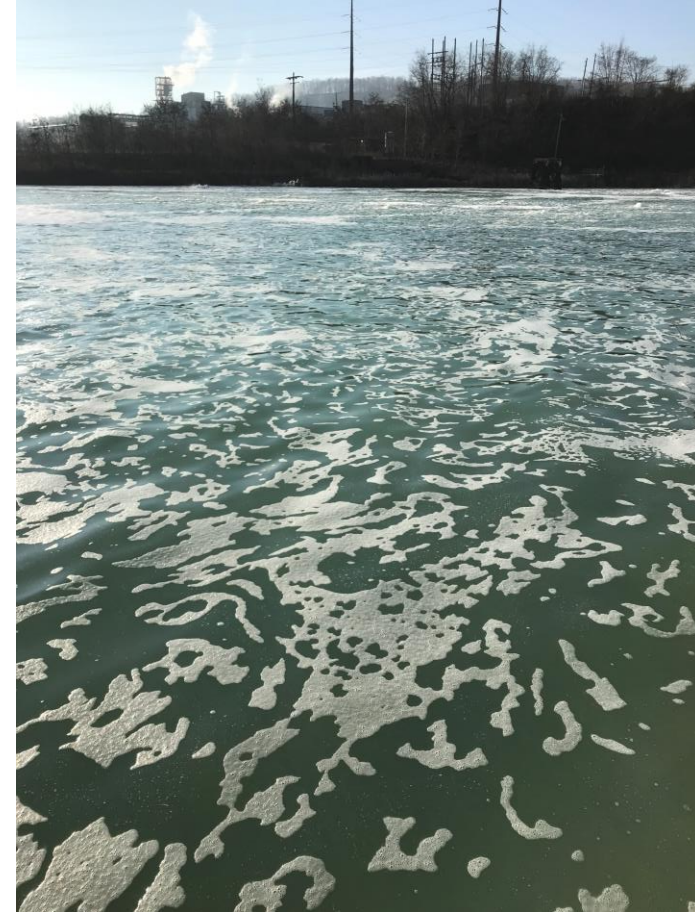
Turbidity screen between aeration lagoon and quiescent pond; foam aeration lagoon

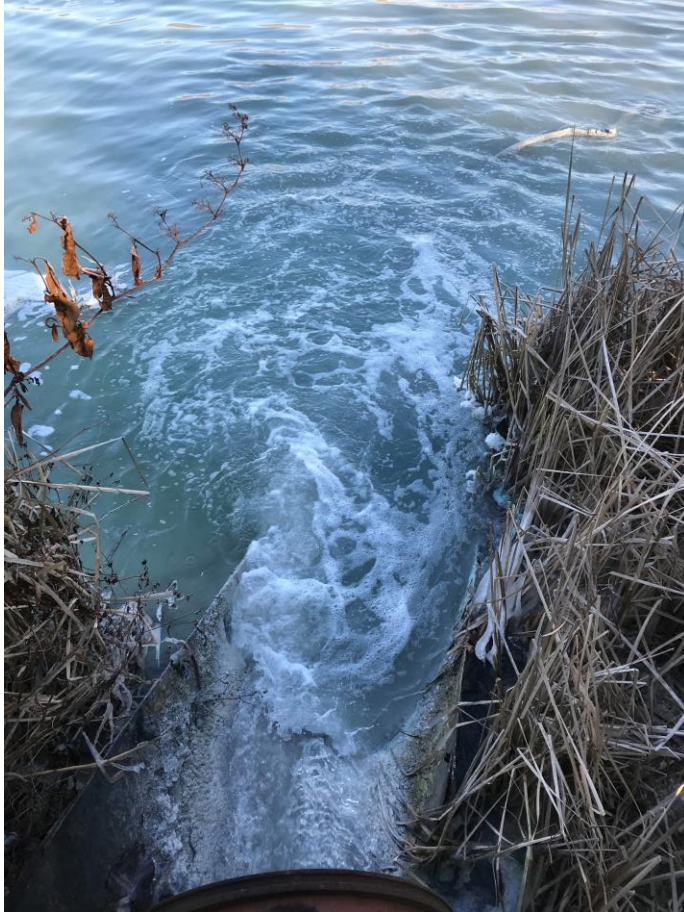
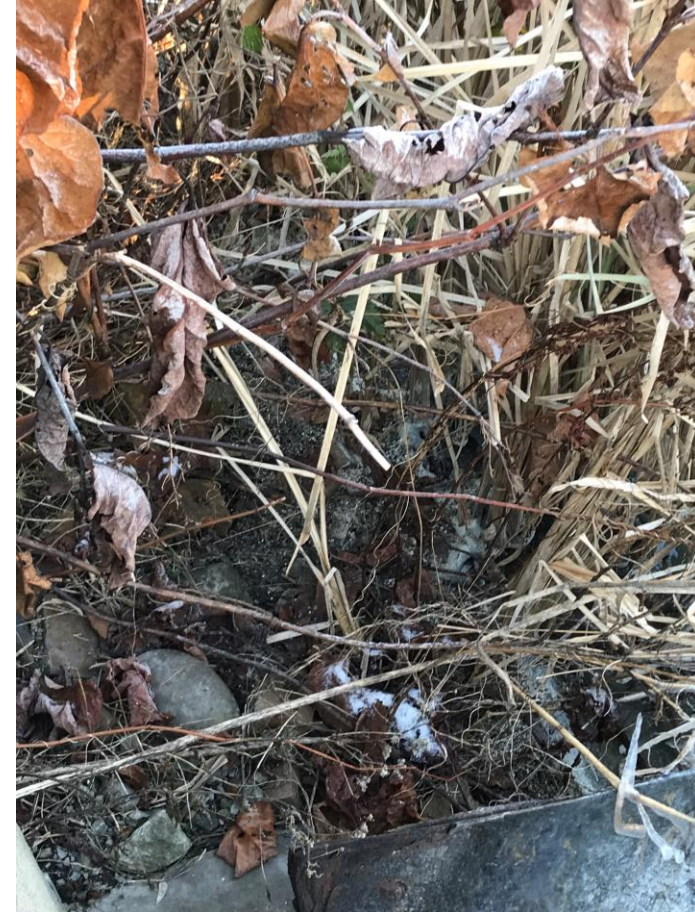
Chute from clarifier/emergency overflow north settling basin; nurdles on shore & vegetation around chute

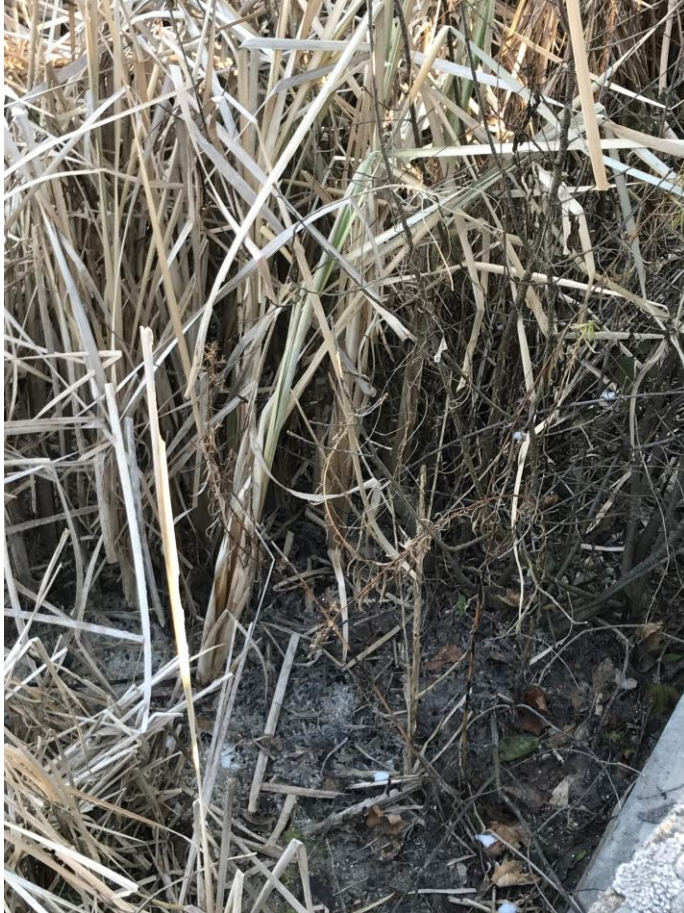
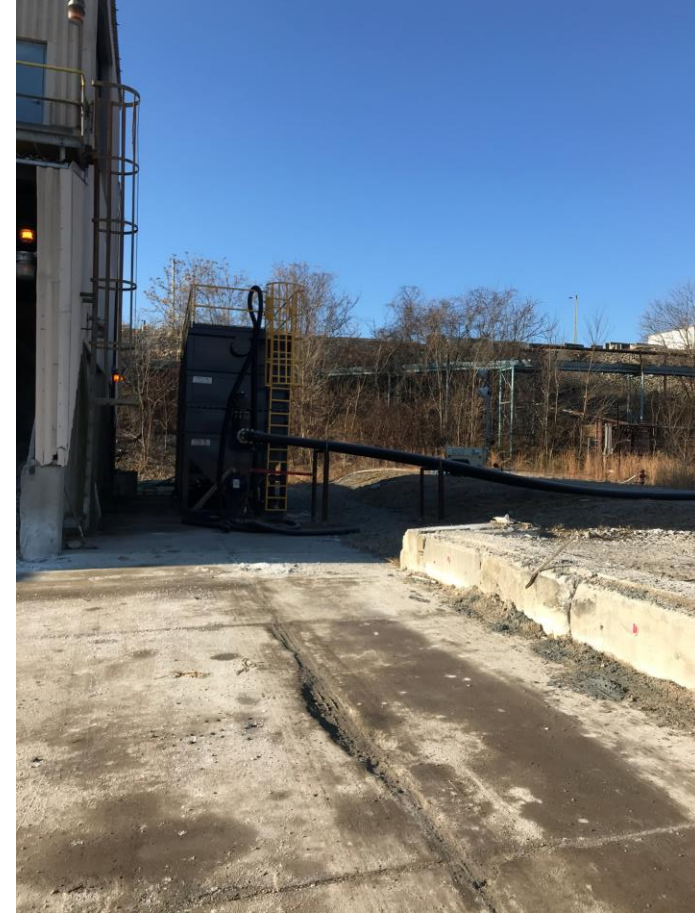
Nurdles near clarifier chute to aeration lagoon; temporary clarifier

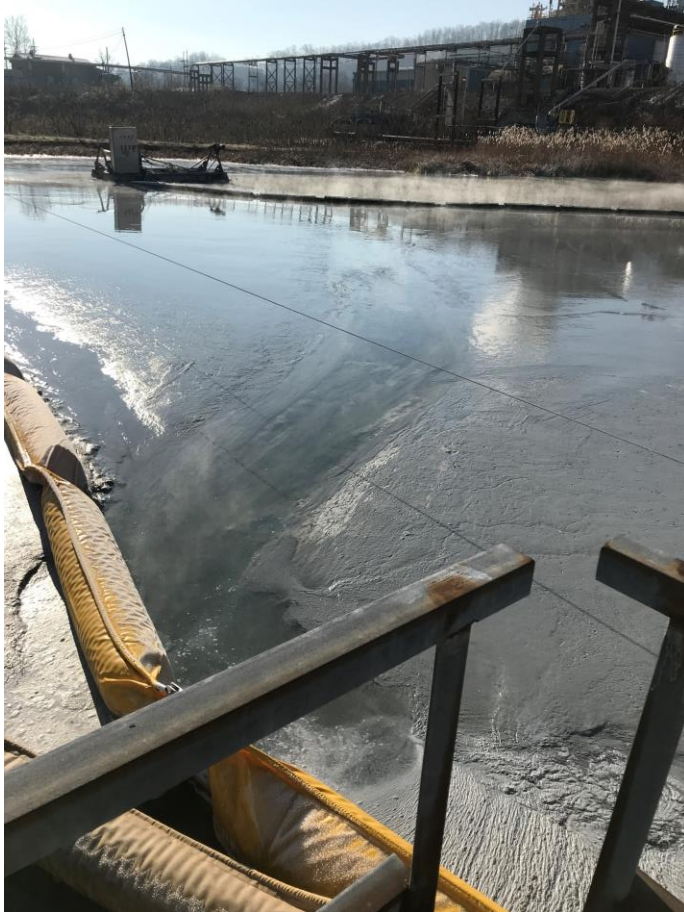
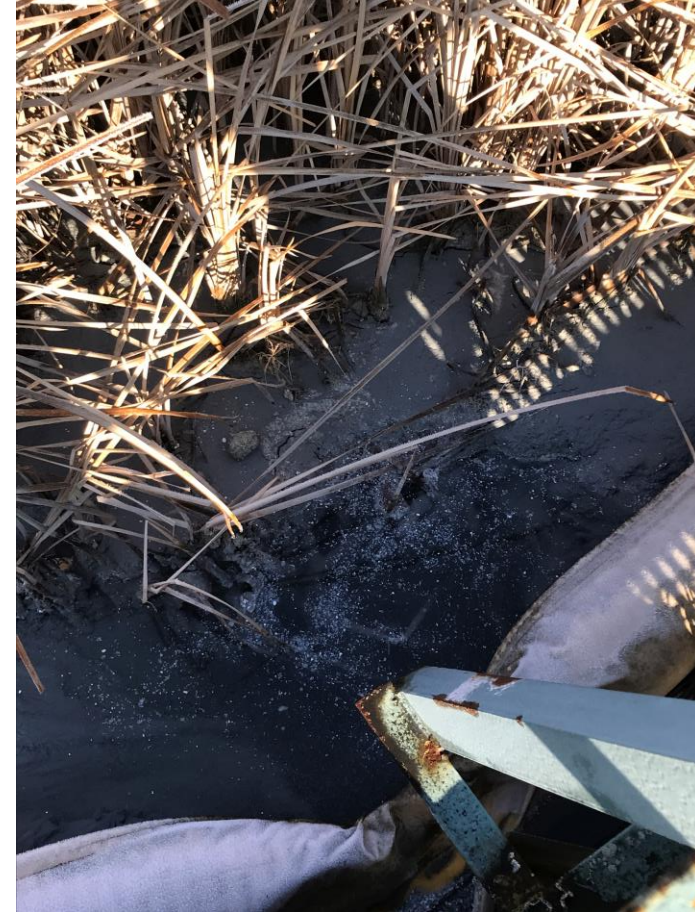
Turbidity blanket and skimmer emergency overflow north settling basin; Nurdles near discharge to aeration lagoon from basin

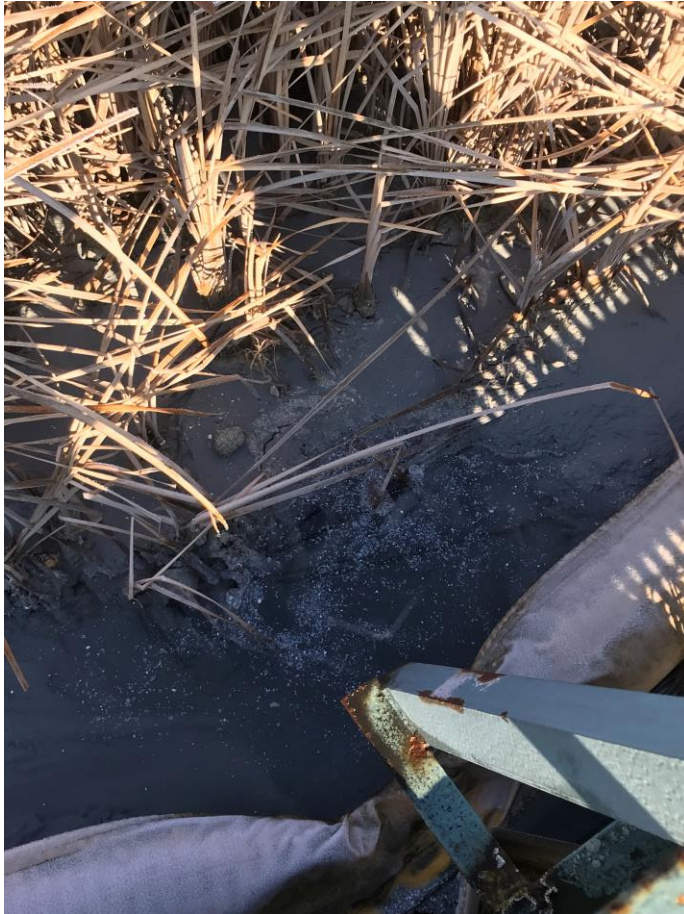
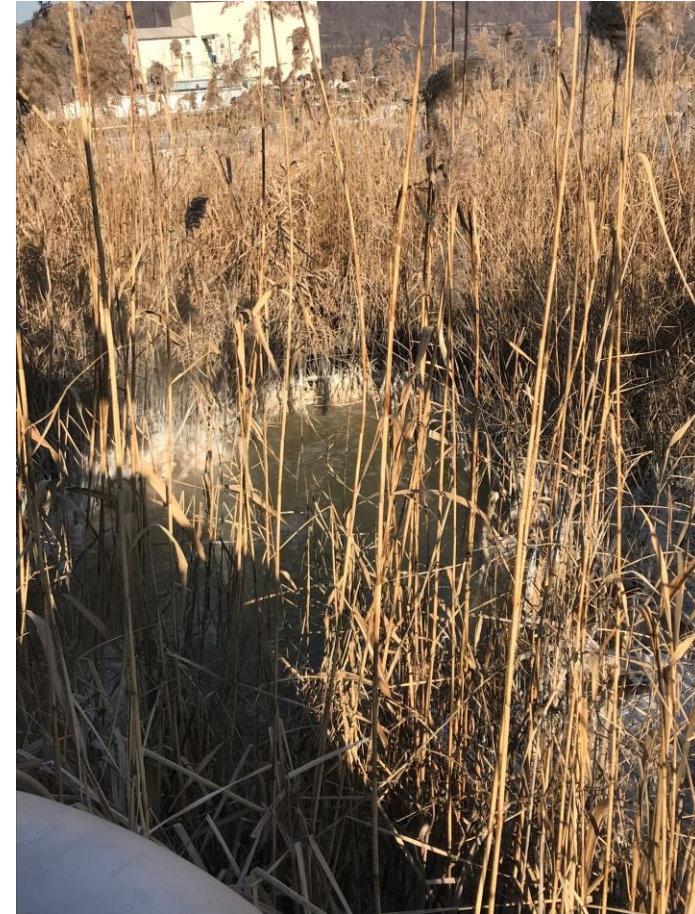
Nurdles in north settling basin along the bank and in the vegetation

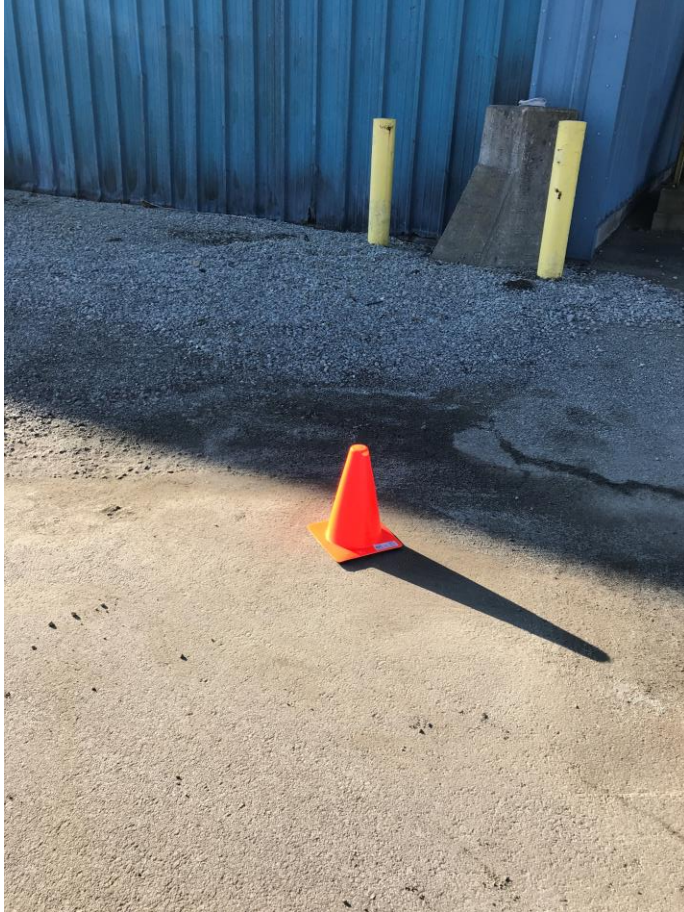
Cone system to identify nurdles on the ground to be cleaned up
